INTRODUCTION

What happens when your broken part is obsolete? Our customer, a manufacturing company, sent us a damaged blower fan. Faced with the challenge of an obsolete part, we utilized reverse engineering, 3D modeling, and advanced manufacturing processes to recreate and enhance the damaged fan.

THE CHALLENGE

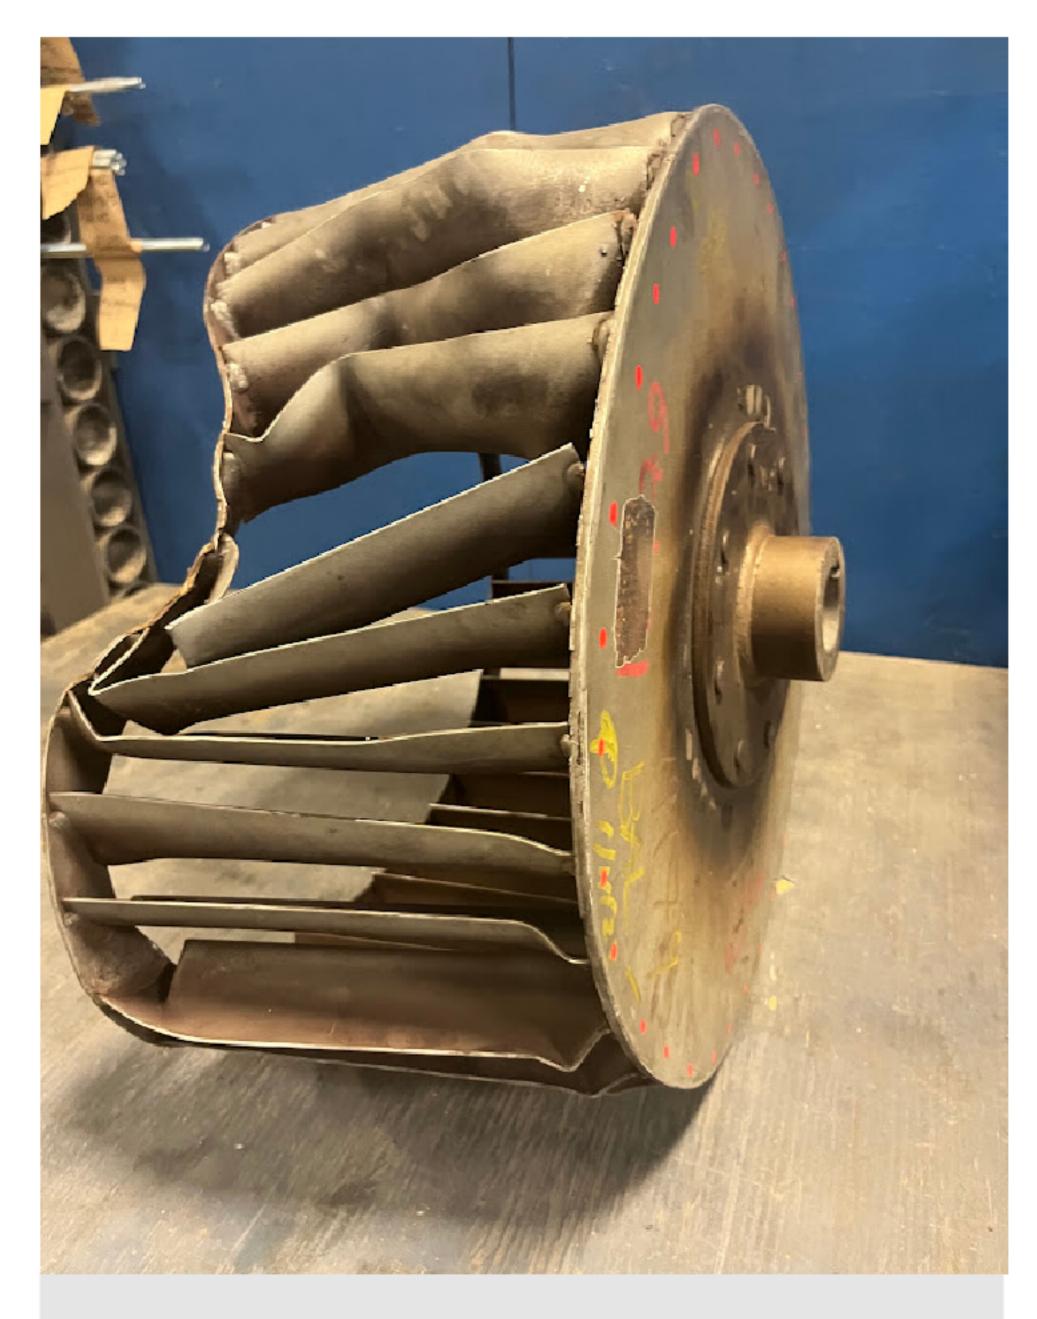
The original blower fan.

- Measurement and Assessment: We initiated the process by measuring the damaged fan, taking into account all dimensions and characteristics critical to its functionality.

- Reverse Engineering Process: Leveraging Autodesk's Fusion 360, we developed a comprehensive 3D model of all fan components, replicating the assembly process based on the acquired measurements.

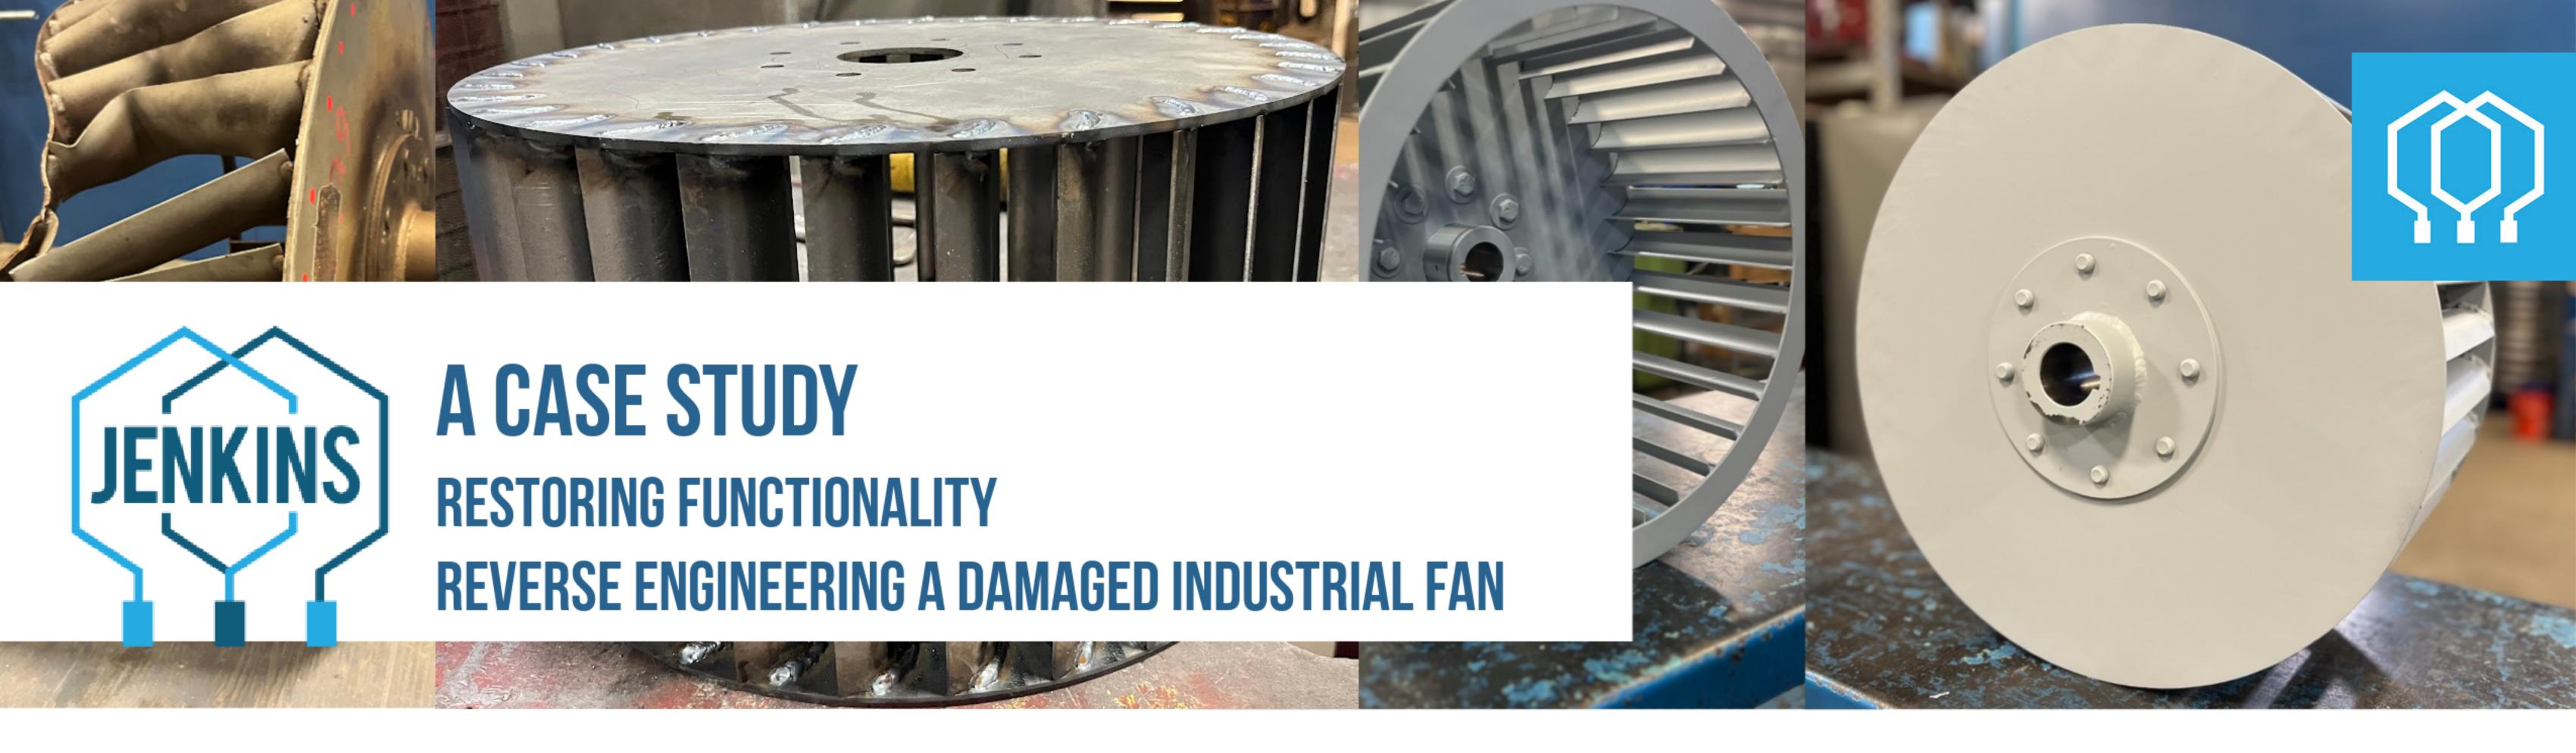
- Manufacturing Techniques: Utilizing advanced machinery, we employed a waterjet for precision cutting of blades, front plate, and backplate. The Haas ST30 Lathe was employed to machine the hub to specifications, while the Milltronics CNC mill drilled bolt hole patterns. The iron worker was crucial for bending the radius on the fan blades.

- Assembly Process: Gordon, our skilled welder, meticulously welded the blades to the front and backplate, defining the fan's form. The flange, a critical connecting piece, was also welded to the hub by Gordon. The final assembly, performed by Austin, ensured the seamless mating of the hub to the fan.

- Quality Assurance: The fan underwent a rigorous test run in the Haas, ensuring concentricity and overall performance met our high standards.
- Finishing Touches: The final step involved cleaning and painting, ensuring the restored fan not only functioned optimally but also looked as good as new.

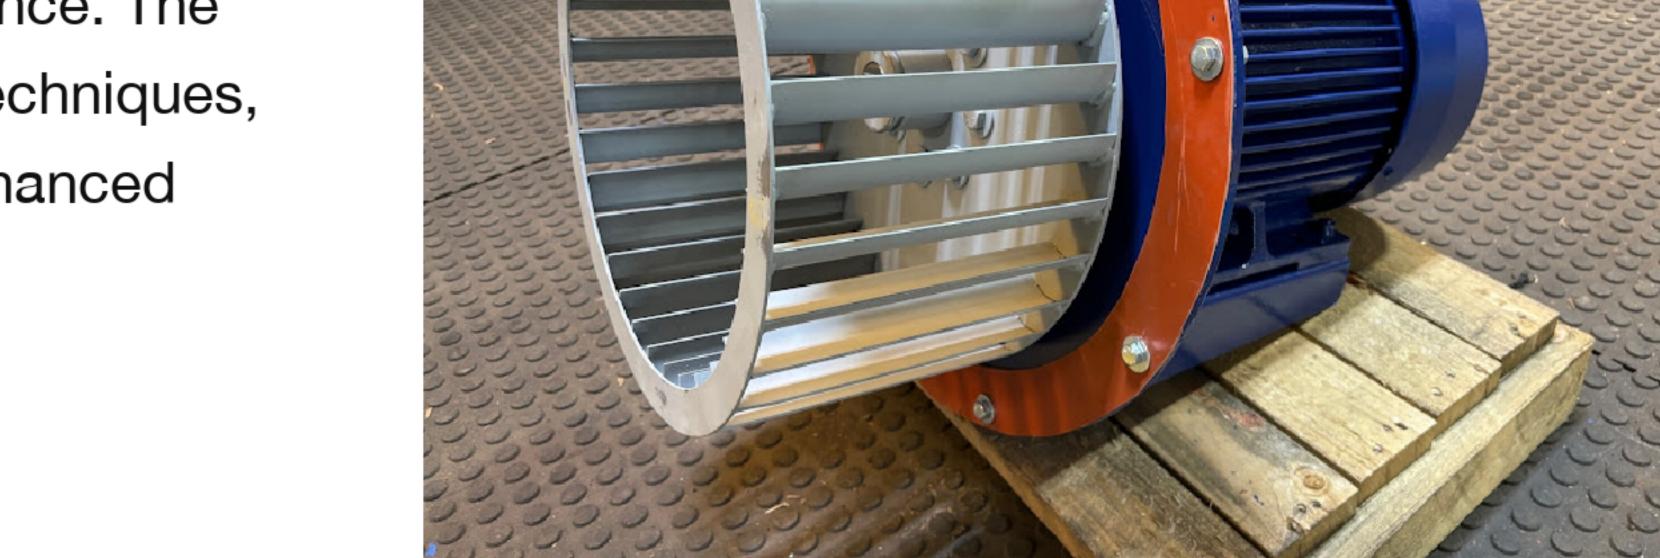
New fan mounted on the motor.

The reverse-engineered fan not only successfully replaced the damaged part but also showcased improved performance. The meticulous measurements, advanced manufacturing techniques, and innovative assembly process contributed to an enhanced product.
